PART I: SEPTEMBER 11, 2001

Chapter 1

NEW YORK CITY'S WORLD TRADE CENTER

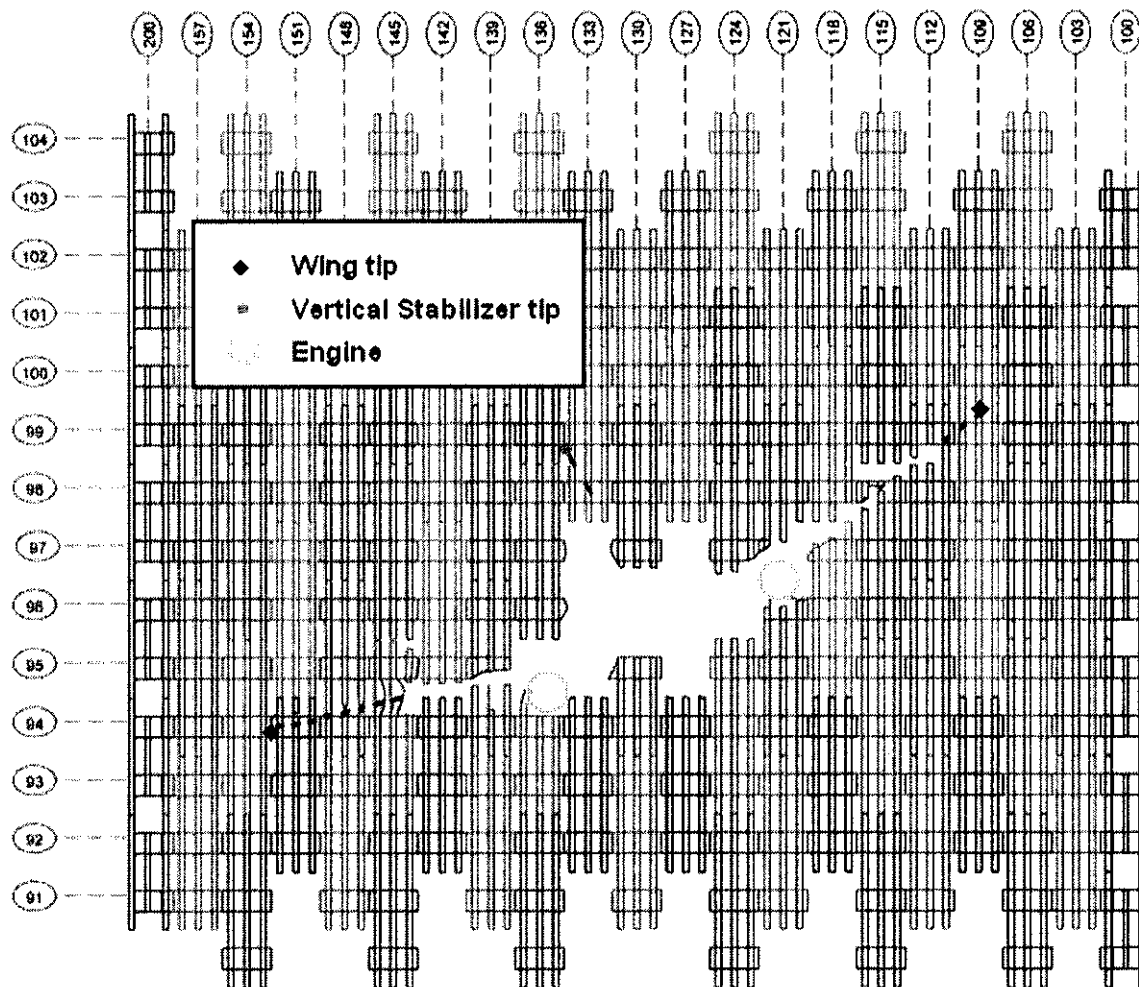
The aircraft did the most damage to the 95th and 96th floors. The fuel-heavy inner left wing hit the 95th floor slab, breaking it over the full 60 ft depth of tenant space and another 20 ft into the building core. The fuselage was centered on the 96th floor slab and filled the 95th and 96th floors top to bottom. The severity of the impact was clear. A wheel from the left wing landing gear flew through multiple partitions, through the core of the building, and became embedded in one of the exterior column panels on the south side of the tower. The impact severed the bolts connecting the panel to its neighbors, and the panel and tire landed on Cedar Street, some 700 ft to the south. A second wheel landed 700 ft further south. Within the two floors, 15 to 18 perimeter columns and five to six core columns were severed, and an additional one to three core columns were heavily damaged. A 40 ft width of the 96th floor slab was broken 80 ft into the building. The insulation was knocked off nearly all the core columns and over a 40 ft width of floor trusses from the south end of the core to the south face of the tower.

Figure 2-3. South face damage of WTC 1 with key aircraft component locations marked.

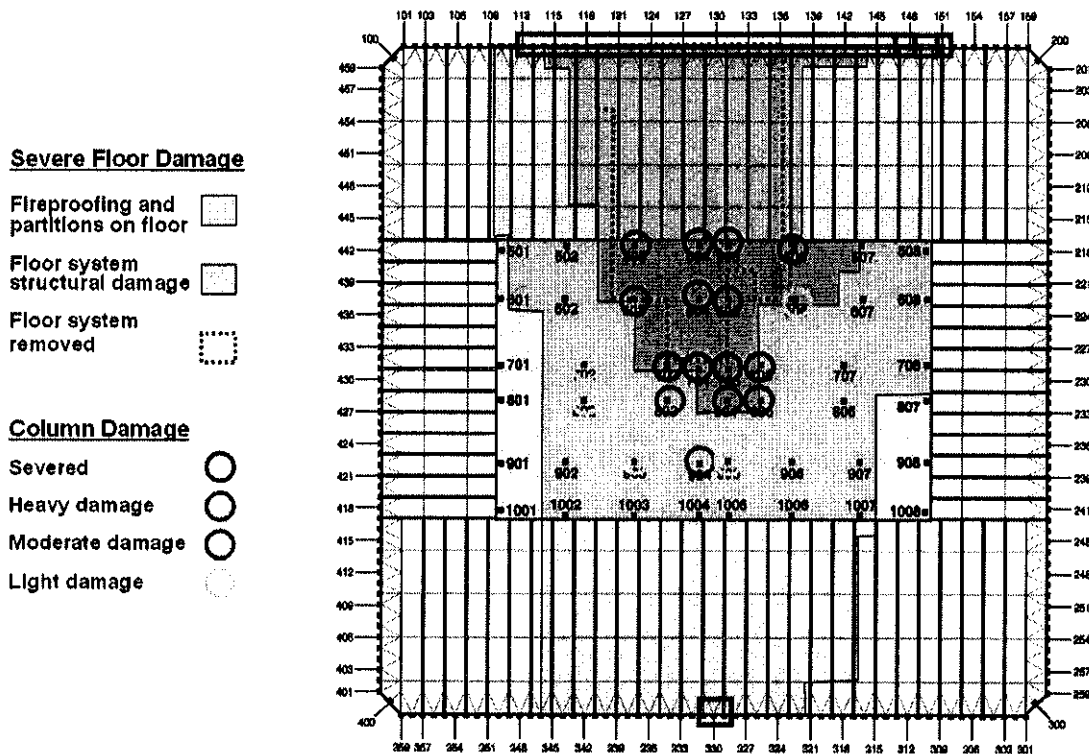
This devastation took 0.7 s. The structural and insulation damage was considerable (Figure 2-4) and was estimated to be:

- 35 exterior columns severed, 2 heavily damaged.
- 6 core columns severed, 3 heavily damaged.

- 43 of 47 core columns stripped of insulation on one or more floors.
- Insulation stripped from trusses covering 60,000 ft² of floor area.

Figure 2-4. Simulation of cumulative aircraft impact damage to floors 93 through 98 in WTC 1.

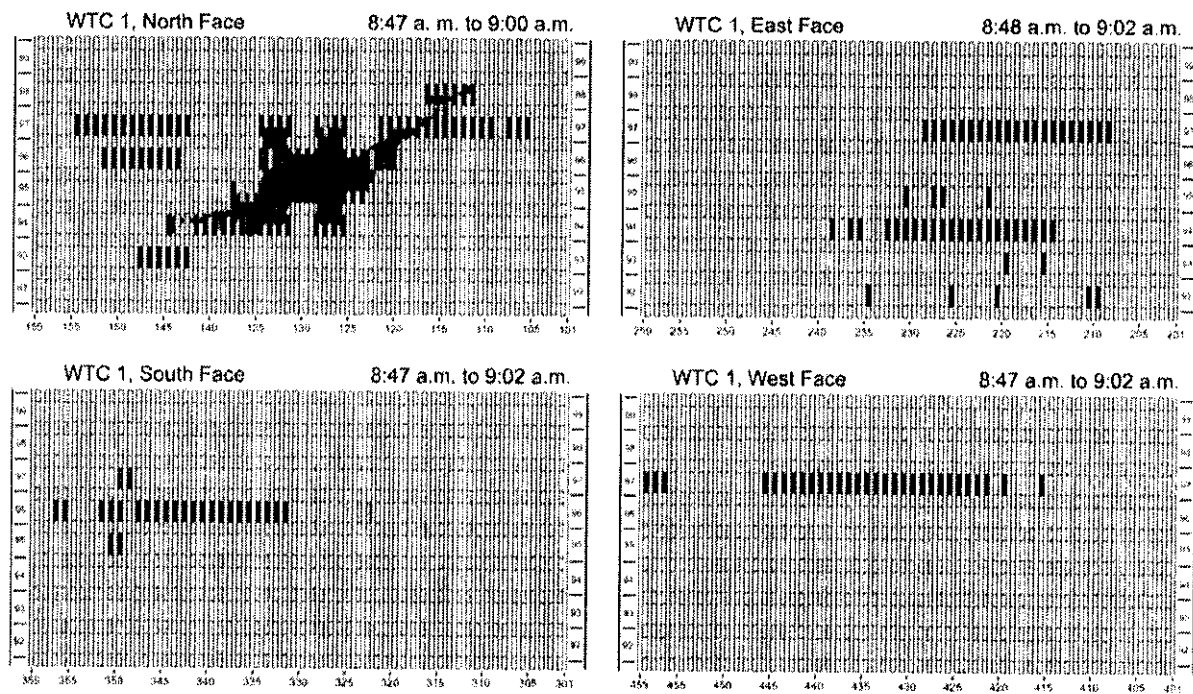
Figure 2-5. Representation of exterior views of the fires on the four faces of WTC 1 from 8:47 a.m. to about 9:02 a.m.

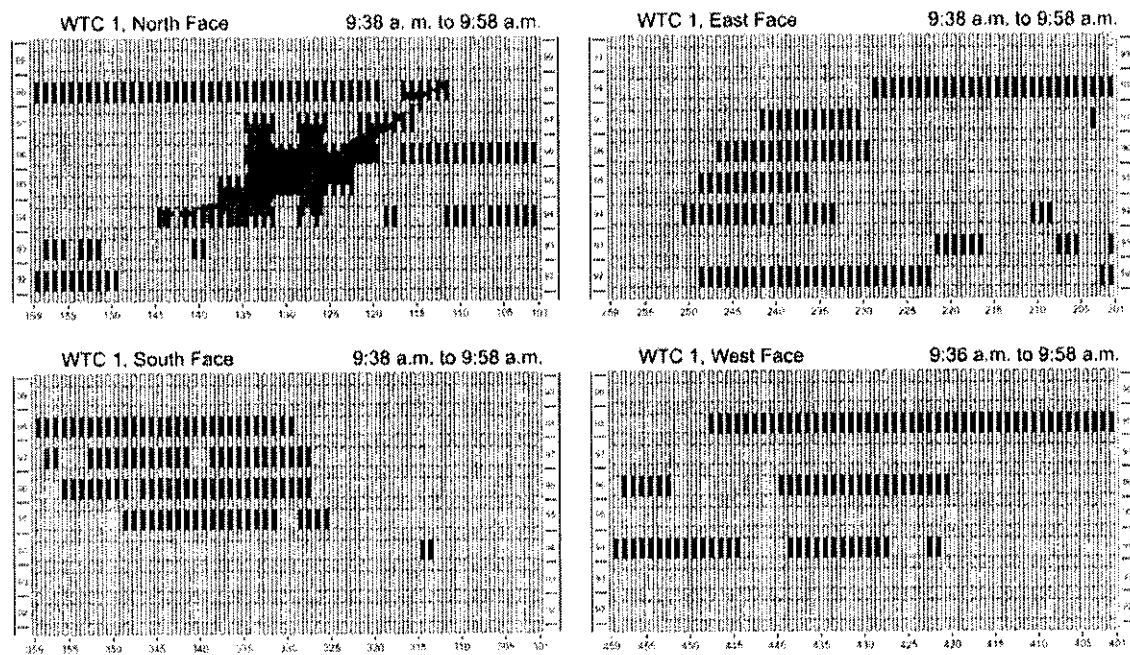
Seventy-five minutes after the impact, approaching 10:00 a.m., the fire on the 97th floor had begun to burn itself out, but the fire on the 94th floor had intensified and filled much of the north half of the floor (Figure 2-7). Starting about 9:30 a.m., there were vigorous fires on nearly the full perimeter of the 98th floor. There was still almost no burning on the 99th floor or above.

Figure 2-7. Representation of exterior views of the fires on the four faces of WTC 1 from about 9:38 a.m. to 9:58 a.m.

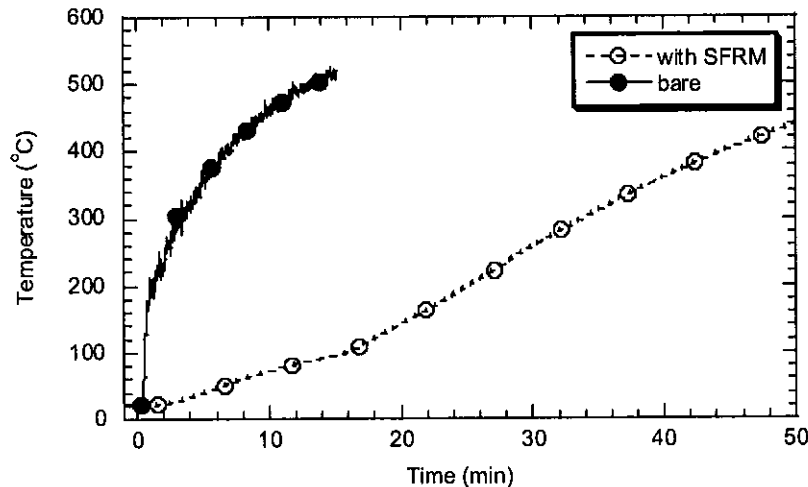
The perimeter columns, floors, and core columns were immersed in these hot gases and began to weaken. Where the insulation was dislodged, the temperature of the steel rose rapidly, in contrast to steel members where insulation was intact (Figure 2–8). The heaviest core columns with damaged insulation heated slowly, as the absorbed heat was dissipated through their massive cross sections. The temperatures of the lighter columns and the floor slabs rose more quickly, and those of the stripped trusses even more so.

Figure 2–8. Steel surface temperatures on the bottom chords of fire-exposed trusses, uninsulated and insulated with ¾ in. of BLAZE-SHIELD DC/F.

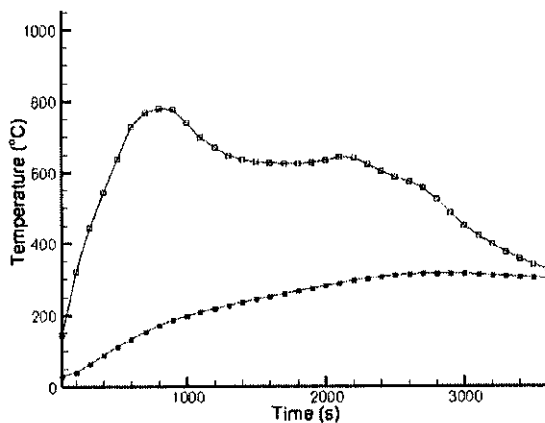
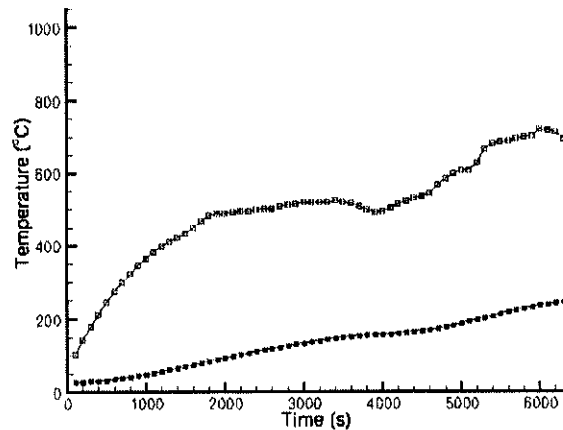
Figure 2-10. Simulated temperatures of two adjacent trusses (left) and two adjacent perimeter columns (right) exposed to the fires in WTC 1.

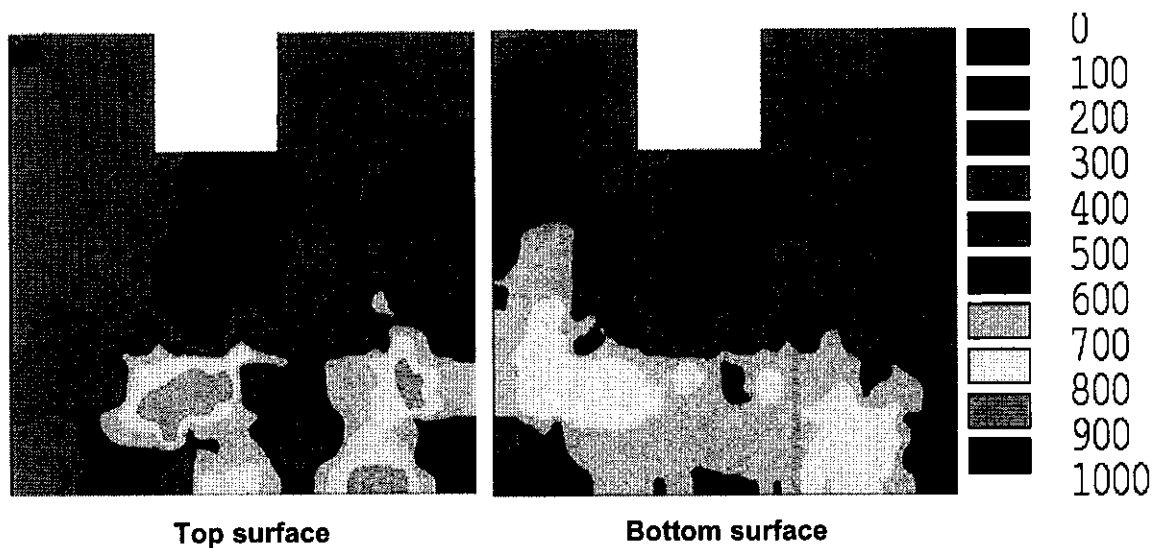
Figure 2-11. Temperature contours (°C) on the top and bottom faces of the concrete slab (96th floor, WTC 1) at 100 min after impact. A portion of the concrete slab on the north face (top) was damaged by the impact of the aircraft.

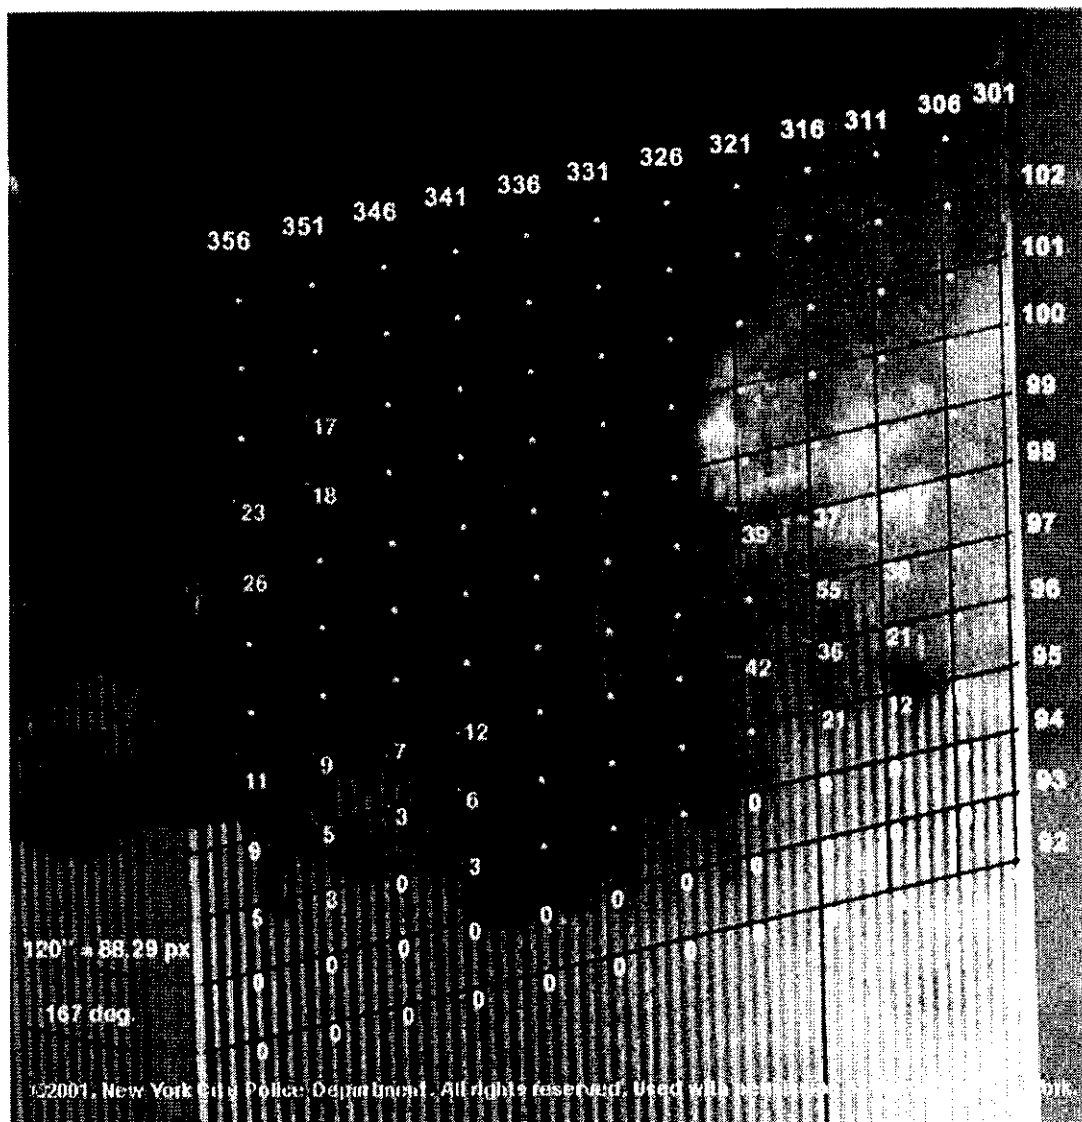
The sagging of the floors had increased. Although the floors on the north side of the tower had sagged first, they contracted due to cooling when the fires moved toward the south. Now, the south side floors had sagged to the point where the south perimeter columns bowed inward (Figure 2-12). By 10:23 a.m., the south exterior wall had bowed inward as much as 55 in.

Figure 2-12. South face of WTC 1 at 10:23 a.m., showing inward buckling (in inches) of perimeter columns.
